## The impact of temporary occupation and hostilities on the water conditions of the North Crimean and Kakhovka Main Canals

✔ **Abstract.** The aim was to analyse the dynamics of water resources of the North Crimean and Kakhovka canals from 2013 to 2024 using remote sensing methods. The study utilised satellite imagery from Landsat 8 OLI/TIRS L2 (2013-2015) and Sentinel-2 L1C (2016-2024). The deep learning model “Water Body Extraction (SAR) – USA” based on Sentinel-1 C band SAR GRD VH data was applied. The normalised difference water index was used to detect water surfaces. Manual digitisation of the canals was performed based on time composites of satellite images over the study period. The analysis revealed significant changes in the water conditions of the canals due to natural and anthropogenic factors. Following the annexation of Crimea in 2014, the cessation of water supply from the Dnipro River led to the drying of canals on the peninsula, negatively affecting agriculture and ecosystems through soil salinisation and degradation. In 2015, the length of canals with water in Crimea decreased to 161.65 km. Alternative sources, such as artesian wells, partially compensated for t

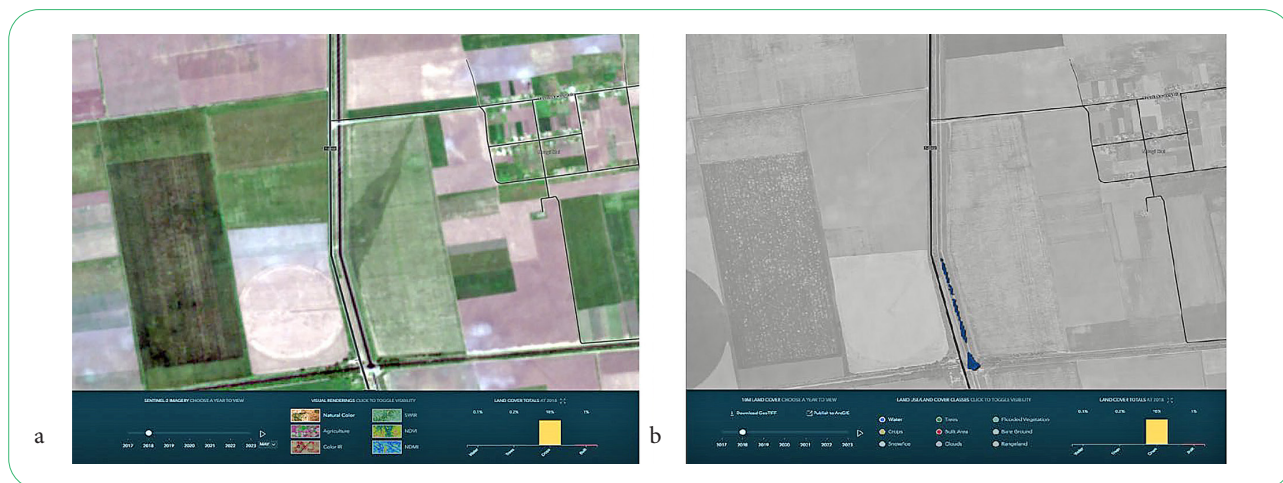
**Figure 4.** Perekop Canal images

especially their smaller branches, was a more complex task for the model. Therefore, the model did not always identify water in the image that the human eye can distinguish. In the 2018 image, it is evident that the Perekop Canal is filled with water (Fig. 4a), but the water in the canal was not identified by the model (Fig. 4b).

**Note:** a – canal with water in Sentinel-2 images, true colour composition; b – identified water in the canal according to Sentinel-2 Land Cover Explorer

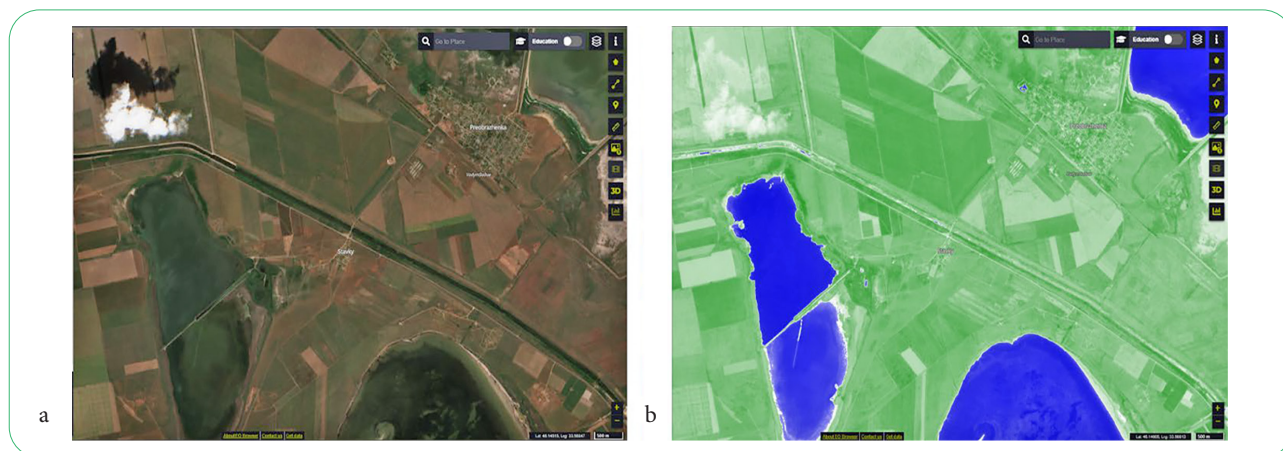
**Figure 5.** North Crimean Canal in Sentinel-2 satellite images

Using the EO Browser (n.d.) resource, the NDWI has been applied to monitor changes related to water content in water bodies. However, this method did not yield the desired results and did not identify water even in the largest canals. In Figure 5a, a part of the North Crimean Canal

is presented in a true colour composition based on Sentinel-2 satellite images. The image shows that the canal is filled with water. However, when the NDWI visualisation was applied to the same section of canal, the water was not identified (Fig. 5b).

**Note:** a – true colour composition; b – NDWI index composition
